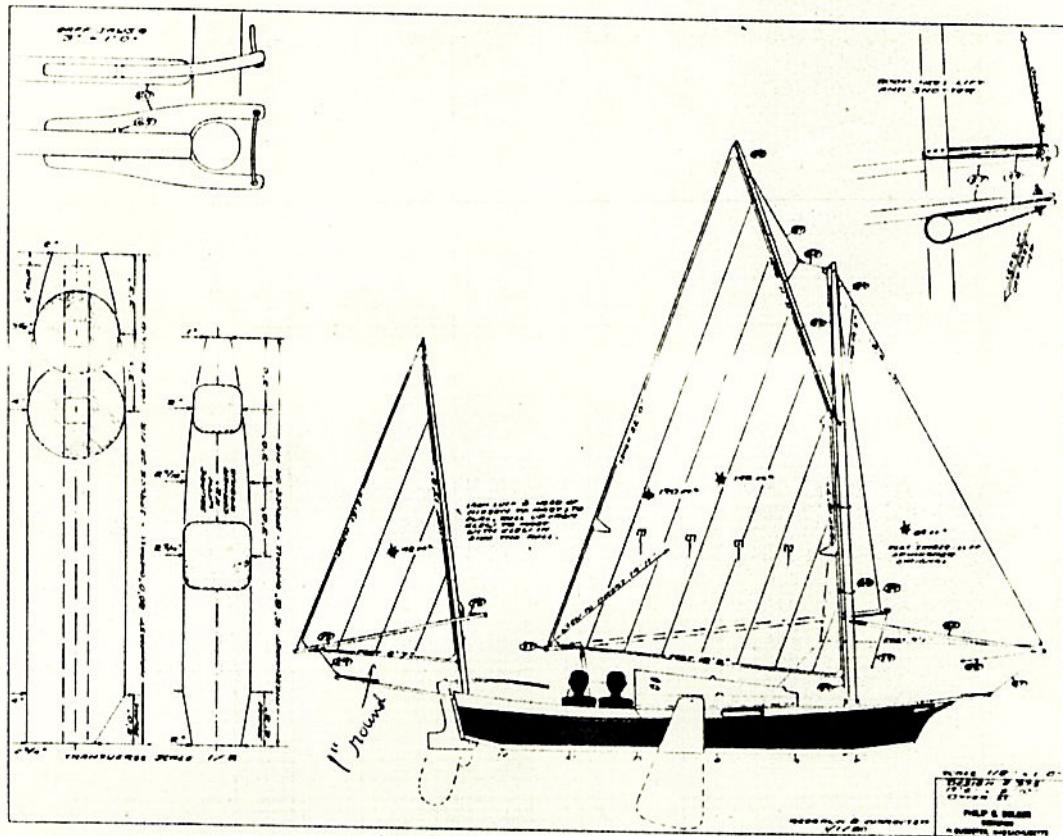
out in several earlier boats. The cuddy is watertight; it can't be flooded in any kind of sudden knockdown, and for ordinary coastwise sailing suitable to her size, it makes her self-righting, without any ballast apart from her bottom structure. One reason this is so is that she doesn't have any buoyancy low down, such as under a self-draining well, to float her in a stable bottom-up position. Her cockpit and the small area ahead of the cuddy are open and can flood over the side or from rain or spray; they must then be bailed with bucket and sponge. But water in those bays can't get into the cuddy.

The stem and stern bays are free-flooding. They have holes in the bottom to let the water out. These ends aren't properly part of the hull at all; they are more in the nature of a bowsprit and a motor bracket, also serving as fairing to improve the flow of water around what's really a square-ended punt 14½ feet long, of which 6½ feet is reliably decked and bulkheaded. This may sound complicated, and it may be in conception (it took me long enough to think of it), but study of the plans and specs will show that it simplifies construction a lot and upkeep
